Manhole Inspection Summary

Manhole # S47II_023MH

Insp Date: **5/2/08 9:09 AM**

Location Address: **Collington Ave**

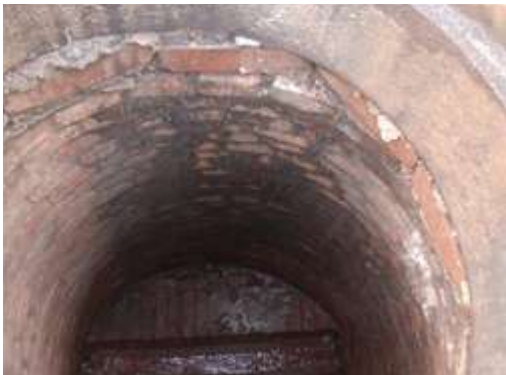
Defect 1

☒ **Leaks**

Frame Leaks

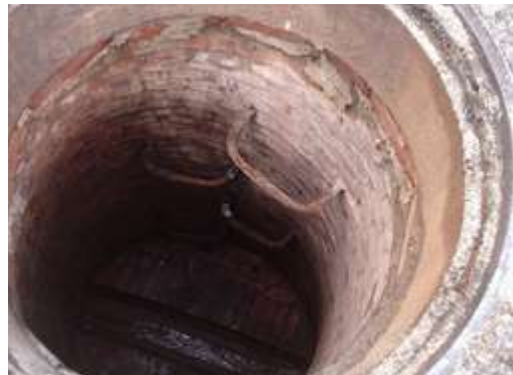
Defect 2

Deterioration

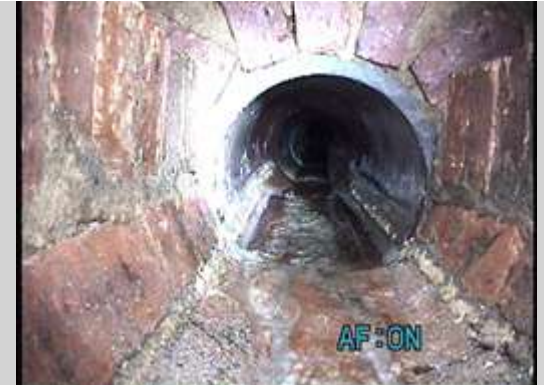
12 O'Clock Outflow

8 in. Circular Gravity Sewer
Pipe Out @ 12 O'Clock

Pipe Height: **8.4** (in.) Rod and Bar (Angled)
Pipe Material: **Clay** ☐ Pipe Lined
Invert Depth: **8.95** (ft.) Flow Characteristics: **Slow**
Deposits: ☒ None ☐ Mud ☐ Sludge ☐ Debris ☐ Grease
Silt Depth: (in.) Deposits Extent:
Infiltration: **None** Pipe Seal Cond: **Sound**

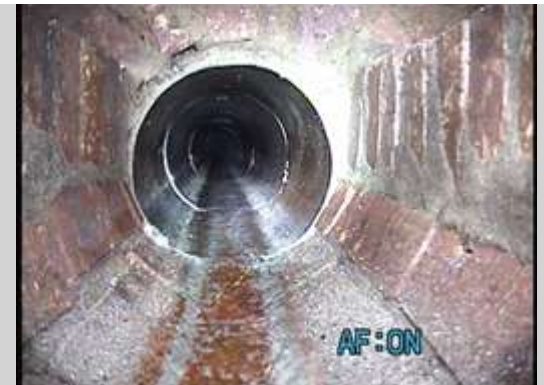
6 O'Clock Inflow

8 in. Circular Gravity Sewer
Pipe In @ 6 O'Clock

Pipe Height: **8.4** (in.) Rod and Bar (Angled)
Pipe Material: **Clay** ☐ Pipe Lined
Invert Depth: **8.80** (ft.) Flow Characteristics: **Slow**
Deposits: ☒ None ☐ Mud ☐ Sludge ☐ Debris ☐ Grease
Silt Depth: (in.) Deposits Extent:
Infiltration: **None** Pipe Seal Cond: **Sound**
